Analysis and Maintenance Scheme Research on Disassembly Inspection of Mine-used Flameproof Motors and Electromagnetic Starters

Zhifeng Wu*

Xi'an Research Institute of China Coal Technology and Engineering Group Corp, Xi'an, Shaanxi
710077, China

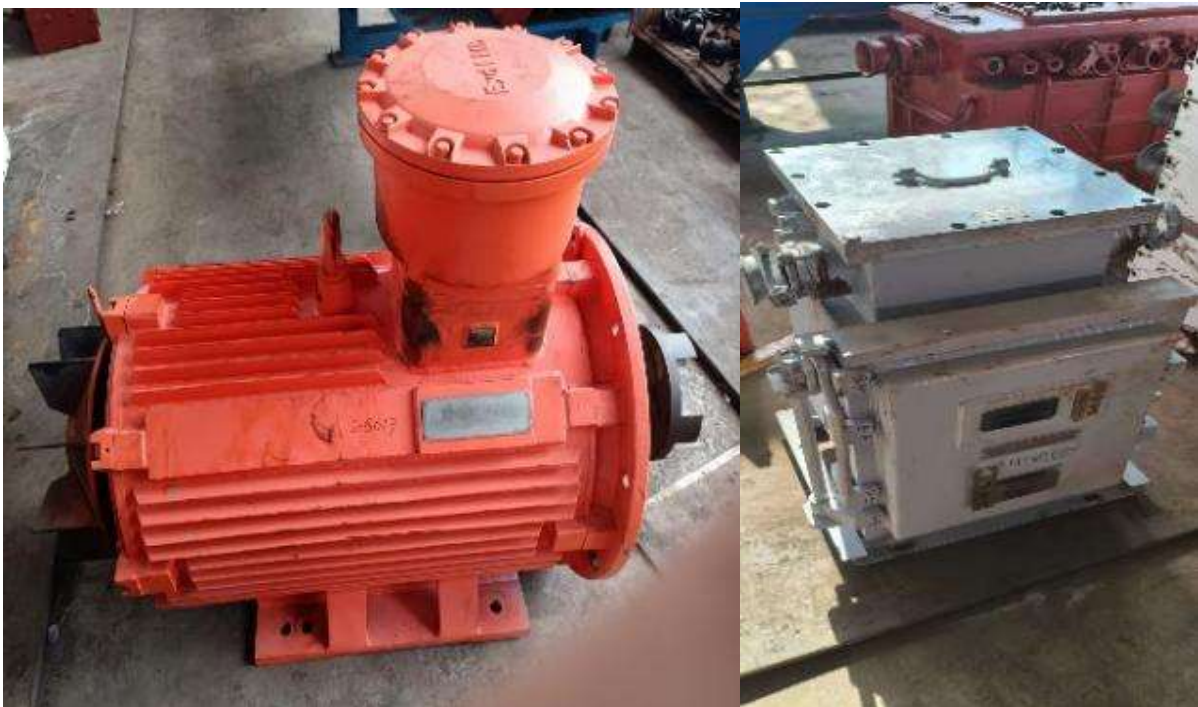
Figure 1. Physical picture of mining explosion-proof motor and electromagnetic starter

This study involves two types of mine-used electrical equipment. The physical object is shown in Figure 1 below. The specific parameters are shown in Table 1. All equipment was submitted by Xi'an Research Institute of China Coal Technology and Engineering Group, with a unified entry time of 45950 (Note: This is an Excel date serial number; the corresponding actual date needs to be converted using the equipment management system).
