"Afflictions" and "Remedies" of Wooden Arch Lounge Bridges

-- Investigation and Intervention of the Damage to the National Protected Site Shunde Bridge

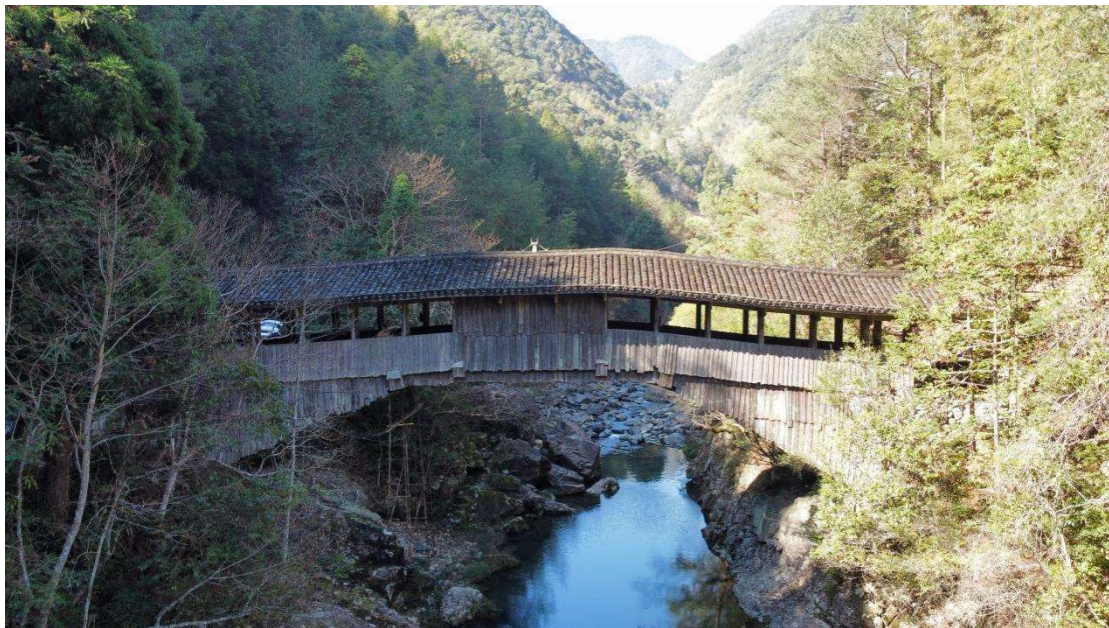
Shunde Bridge (Figure 1) is located in Yangshun Village, Pingnan Town, Longquan City, spanning the Mei River on an east-west axis. The existing bridge has a total length of 36 meters and a width of 4.84 meters. Originally featuring a lounge with 17 bays, one bay at the eastern end was demolished and reconstructed due to road construction. Its core value is embodied in the unique "timber-weave

arch" structural system. This system consists of two layers: the lower layer is an A-shaped arch frame (known as sanjiemiao, or three-section seedlings) composed of three long logs, while the upper layer is a five-segmented polygonal arch frame (known as wujiemiao, or five-section seedlings) formed by five slightly shorter logs. The turning points of the arch frames are tightly connected by transverse large timbers called niutou (bull's head), integrating them into a cohesive whole. Bridge deck planks are laid flat over the arch frames, upon which the lounge structure is built. This technique, centered on mortise-and-tenon joints, achieves a stable arch form through the interlocking, compression, and mutual restraint of timber members, representing an outstanding example of ancient bridge engineering. The lounge structure employs a post-and-lintel (tailiang) framework with a flush-gable roof, covered with small black tiles. Its overall form is simple, rustic, and substantial, blending harmoniously with the surrounding mountainous landscape.

Figure 1. Shunde Bridge(self-drawn)

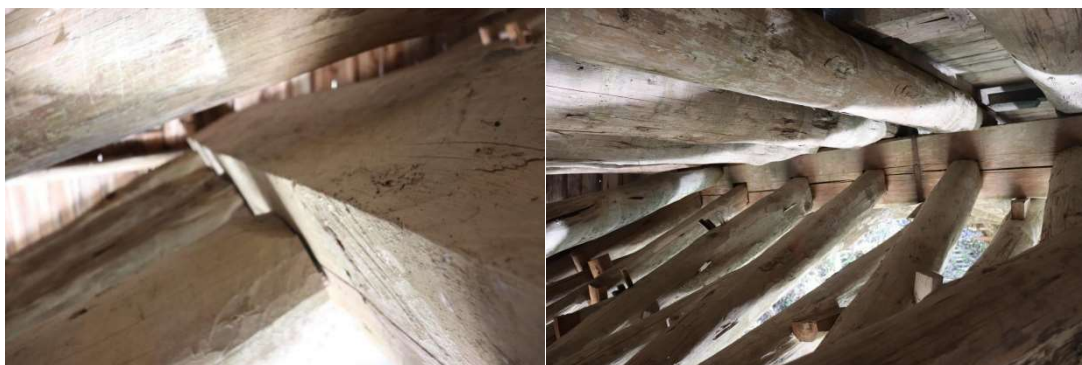
(1) Wooden Weave Arch Structure: The investigation revealed that the wooden weave arch, particularly the "three-section seedling" system which serves as the primary load-bearing component, suffers from the most severe damage, posing a direct threat to the overall structural safety. Sliced data from the 3D scan clearly shows significant issues with the eastern and western sets of inclined seedlings: The lower section (approximately 1 meter) of the eastern inclined seedling (A-5) has decayed, and component A-2 exhibits a 70% insect infestation rate throughout its length; the root section of the western inclined seedling (C-1) also shows approximately 1.2 meters of insect-induced decay (Table 1). More critically, signs of cracking and tenon withdrawal have appeared at the mortise-and-tenon joints connecting the inclined seedlings to the "bull's head" timbers. As shown in Figure 7, there is a crack of about 10mm at the junction between the western bull's head timber and the inclined seedlings C-3 and C-4, with some bull's head timbers themselves exhibiting mid-section cracks of 5-10mm. These damages, located at key load-bearing nodes, significantly compromise the integrity and load-bearing capacity of the wooden arch structure and constitute the core cause of the bridge's structural risk.

Figure 5. Left: Middle cowhead misalignment at the upper west end of a three-segment seedling;
Right: Cowhead cracking on the west side of a three-segment seedling (drawn by the author)

Restoration of the Wooden Arch: This is the core of the restoration. Key components such as three-section seedlings, five-section seedlings, and bull's-head timbers with insect damage or decay exceeding safety limits will be replaced strictly according to original specifications and traditional craftsmanship. For components with cracks that can be retained, traditional techniques (e.g., resin injection, adding metal bands) will be used for reinforcement. All mortise-and-tenon joints will be refitted to ensure tight engagement. During reassembly, 3D scan data will serve as the benchmark for precisely correcting the arch's geometry and restoring its intended mechanical form.

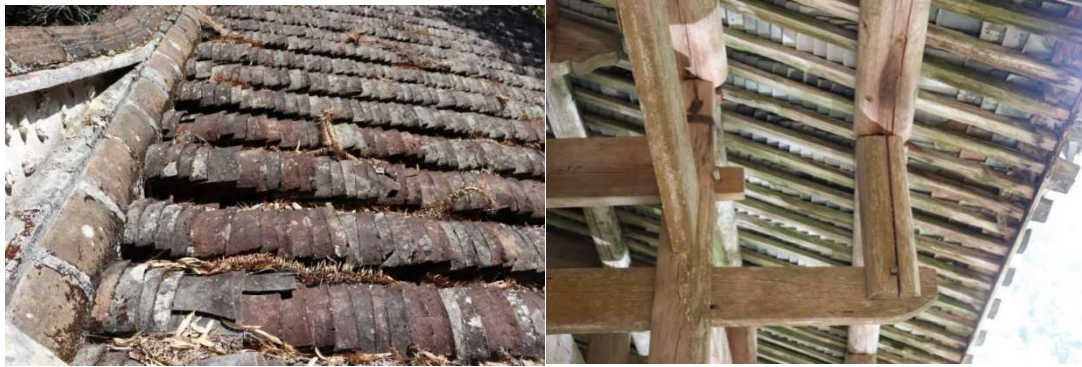
The roofing system is severely deteriorated, with cracked and missing tiles leading to direct rainwater infiltration. Persistent leakage has caused widespread dampening of the underlying wooden substrate (rafters, fascia boards), resulting in moldering and decay (Figure 6). This not only accelerates timber degradation and adds to the load, but the damp environment also fosters conditions for wood-decay fungi and insect infestation, creating a detrimental synergistic effect with the structural damages.

Figure 6. Left, damaged roof tiles with leaves blocking drainage; right, rotted eaves with water leaks, rafters damp and moldy (self-drawn)

Restoration of the Roofing and Enclosure System: The roof's wooden substrate will be comprehensively inspected and repaired. Decayed rafters and sheathing boards will be replaced. The small black tile roof will be re-laid using local traditional techniques, with improved drainage to ensure waterproofing. Damaged weatherboarding will be repaired or replaced.
