Suggestions for Anti-Floating Design of Basement Structures in Weakly Permeable Layers

Zhenlan Zhao^a, Bowang Chen^b, Wanqiong Xie^c, and Chao Tan^d

College of Civil Engineering, Central South University of Forestry and Technology, Changsha 410004, China

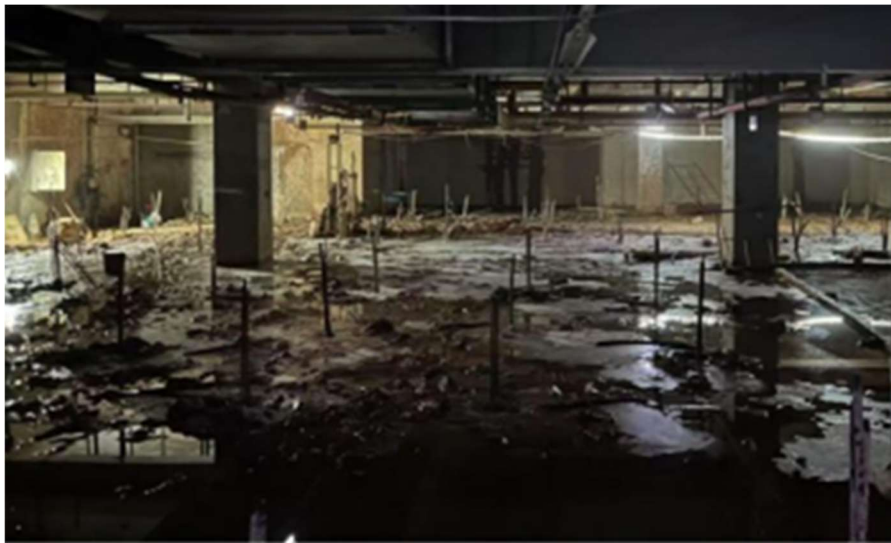
In cases of buoyancy failure, remedial action often involves installing additional anchor rods due to previously underestimated design water levels. However, this process differs significantly from initial construction. After backfill, the soil around the basement has been restored, making it difficult to drain water efficiently as in open-pit conditions. Dewatering can only be done via relief wells, which proves inadequate in loose backfill conditions due to high permeability. Each rainfall episode leads to continuous groundwater seepage through the anchor rod holes, as illustrated in Fig.1 Relying solely on limited relief wells cannot control the overall water level effectively, particularly near exterior walls, where water accumulates faster and infiltrates more intensely, imposing greater construction risks.

Fig.1 Reinforcement Construction Photograph

To mitigate this issue, grouting in the backfill zone is commonly adopted to block seepage paths and limit rapid rainwater infiltration. While effective, this method incurs significantly higher costs than standard drainage solutions. It highlights that failure to properly evaluate design water levels, ensure backfill compaction, or assess the dynamic hydrological conditions during the design stage may result in higher post-construction costs and remediation complexity. Therefore, anti-floating design must go beyond local structural measures and take an integrated approach-considering geological conditions, structural configuration, construction processes, and long-term groundwater fluctuations-to ensure overall project safety and stability.

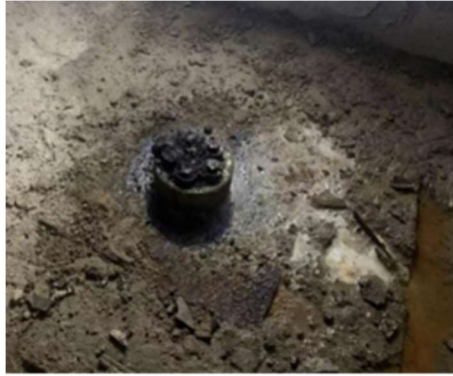
- 4) Absence of pre-installed re-grouting ports in the steel sleeve means that after tendon tensioning, the anchor head and bearing plate block access to the sleeve, resulting in poor grout compaction and groundwater infiltration along the sleeve wall, as shown in Fig.2.

Fig.2 On-site Photograph of Anchor Rod Leakage

Therefore, designers and contractors should establish clear specifications for anchor type selection, waterproofing details at anchor-slab connections, grout sequence planning, and re-grouting provisions to ensure durable and watertight anchorage systems.
